## Service Information SI-AT01-018

Type: AQUILA AT01,  
 Models: AT01; AT01-100; AT01-200  
 affected S/N:

Continuous modifications and changes to parts and appliances are cumulatively detailed and published within this SI.

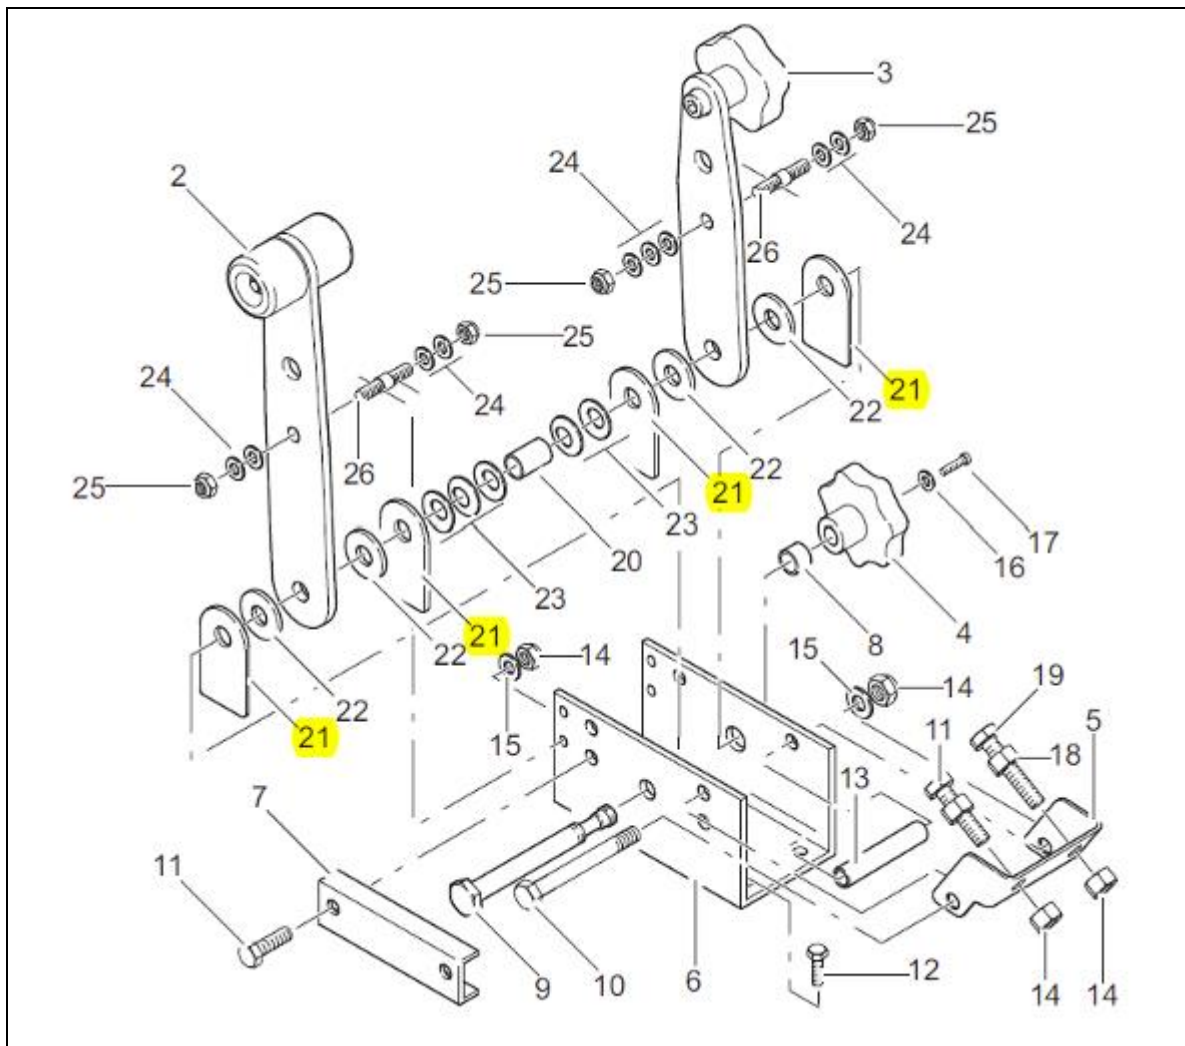
figure 1: improved engine control quadrant (7020-001-010-R01)

In case of necessary exchange of the engine control quadrant (7020-001-010) an improved version (7020-001-010-R01) is recommended.

Also a retrofit (see figure 1, position 21) is possible, if the 4 washers (DIN9021 8,4x24mm) are replaced by the four metal sheets (7020-145-R00).

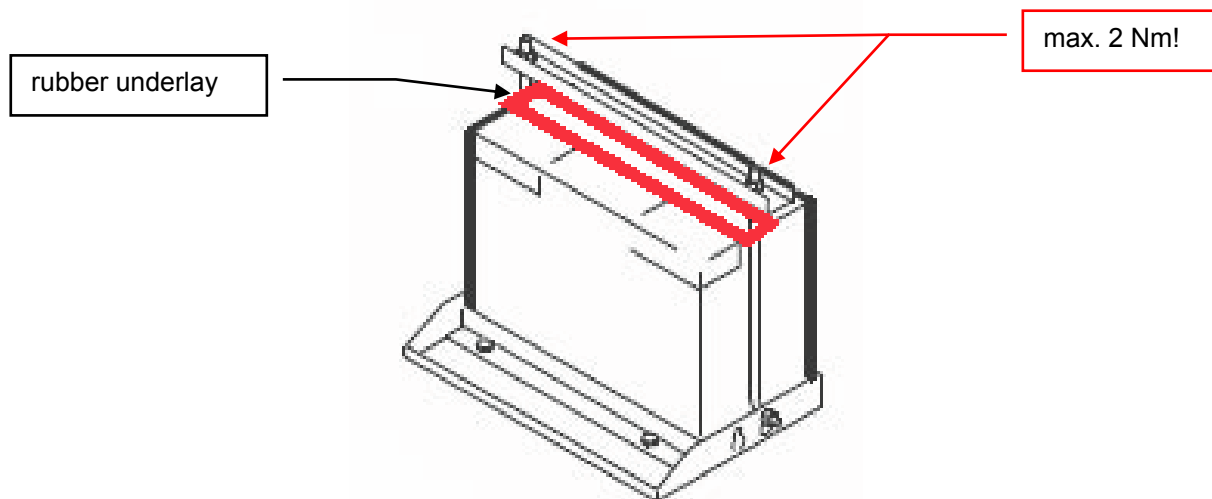
To avoid mechanical damage to the battery a rubber underlay 1,5x175x15mm (glued with double-faced adhesive tape to the aluminum U-profile) between the battery hold down bracket (Al-U-profile) and the battery is recommended.

Also the recommended torque for the self-locking nuts at the hold down bracket is **max. 2Nm**.

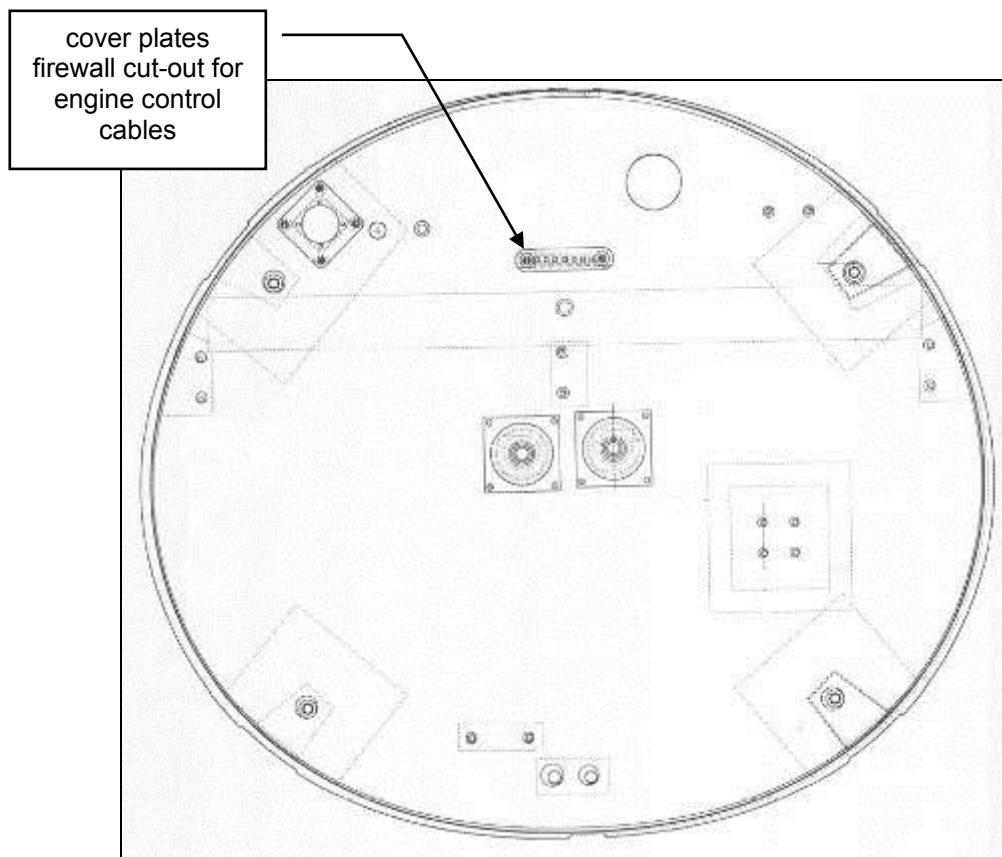
firewall AQUILA AT01 model AT01 and AT01-100

In case of increased friction or friction induced noise within the engine controls (throttle, propeller- or choke lever) it is a possible cause that the cover plates at the firewall cut-out have cut into the casing of the engine control bowden cables.

Therefore an exchange with thicker plates (1,0mm) is recommended.

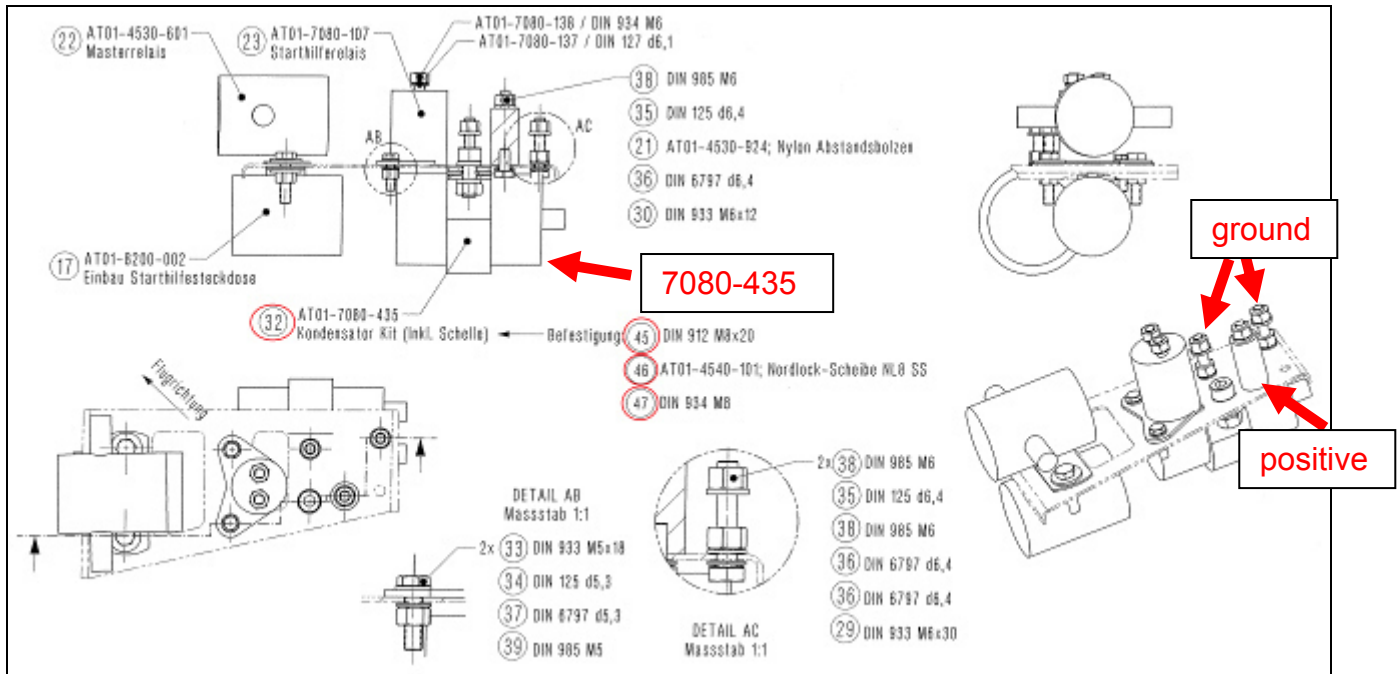
To minimize interference induced by voltage fluctuations, retrofit of a capacitor for the external generator is recommended.

- mechanical connection onto electrics holding plate at engine mount depending on version as far as possible according to drawing:

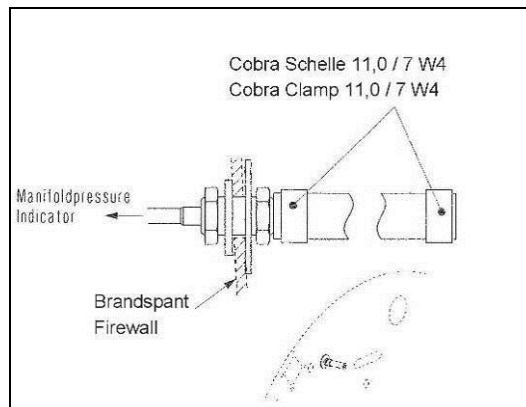
In some cases the manifold pressure connecting hose from the firewall to the carburetors connecting bridge is attached with tie wraps. To ensure an accurate measurement Cobra clamps should be used.

**new:** 2x Cobra clamp 11,0 / 7 W4 (AQUILA P/N **4520\_COBRA\_11,0/7W4**)

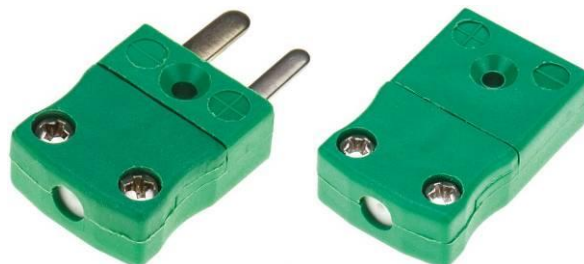
**Alternative K-type thermocouple inline connector (Aquila P/N plug 4530-252, socket 4530-253)**

The soldering equipment typically available in maintenance shops is not suitable for thermocouple wire alloys. Standard connectors based on plated copper will introduce errors in the measurement due to additional junctions between dissimilar metals. Therefore, butt splices, solder sleeves, copper wire etc. are not allowed to be used in repairs of thermocouple wiring.

As an alternative to overlap connectors, the above K-type thermocouple connectors may be installed. These connectors feature contacts made from thermocouple alloys.

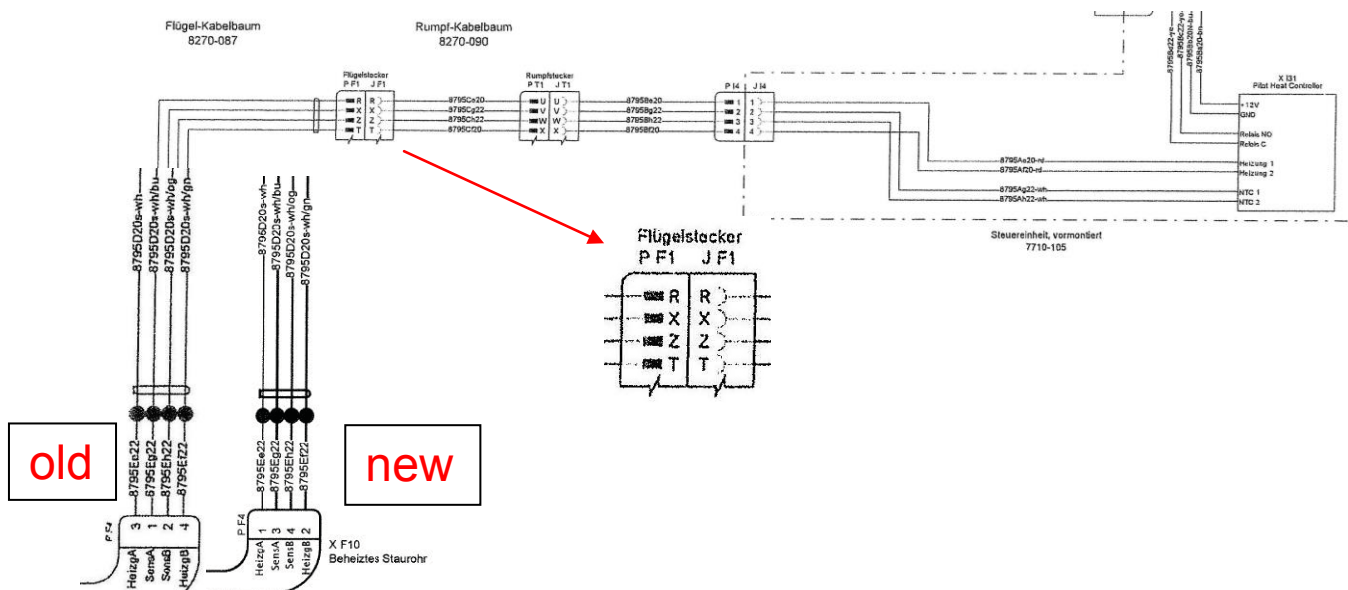
The design of the heated pitot tube with pressure sealing via a screwed cable gland had a high scrap rate due to leakiness. A new version with Lemo socket and Lemo plug was approved. Now the pin assignment at the Lemo socket / plug has been changed.
