REPUBLIC OF SLOVENIA  
MINISTRY OF INFRASTRUCTURE

Number: 37200-5/2022/83  
Date: 13. 03. 2024

**FINAL REPORT**  
**ON THE ACCIDENT INVESTIGATION**  
of the AQUILA AT01 motor aircraft,  
reg. mark OE-CYY,  
near Lesce airport (LJBL),  
August 5, 2022

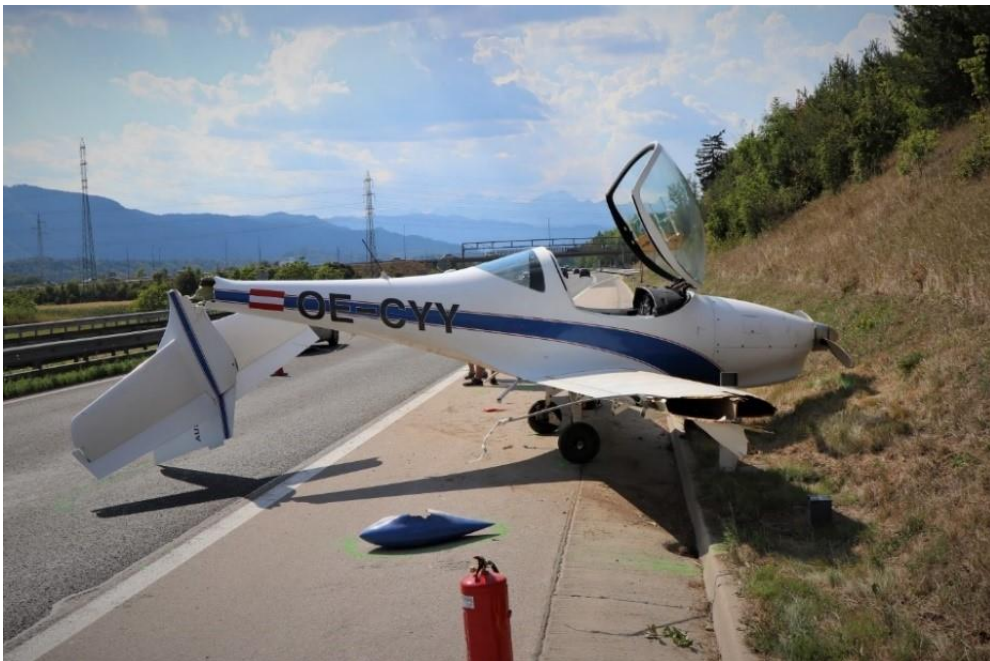
Figure 2: Position and damage of the OE-CYY at the stop point

The aircraft landed on the Gorenjska highway in the direction of Jesenice. During the landing on the highway, the aircraft was not damaged until the moment when the pilot steered the aircraft to the far right of the runway to avoid a collision with vehicles, causing the right wing of the aircraft to slide along the embankment at the edge of the highway. During heavy braking and sliding of the right wing against the terrain, the nose leg of the landing gear was damaged (aerodynamic covers of the landing gear wheels, tyres), part of the right wing, right flap, and aileron of the aircraft were broken off and fell off, and the tail of the aircraft was damaged (broken off). Surface cracks were visible on part of the left wing. The propeller also showed surface damage. A small amount of fuel leaked from the fuel drain valve, which was pushed by the edge of the cracked abutment onto the concrete curb next to the damaged nose leg.

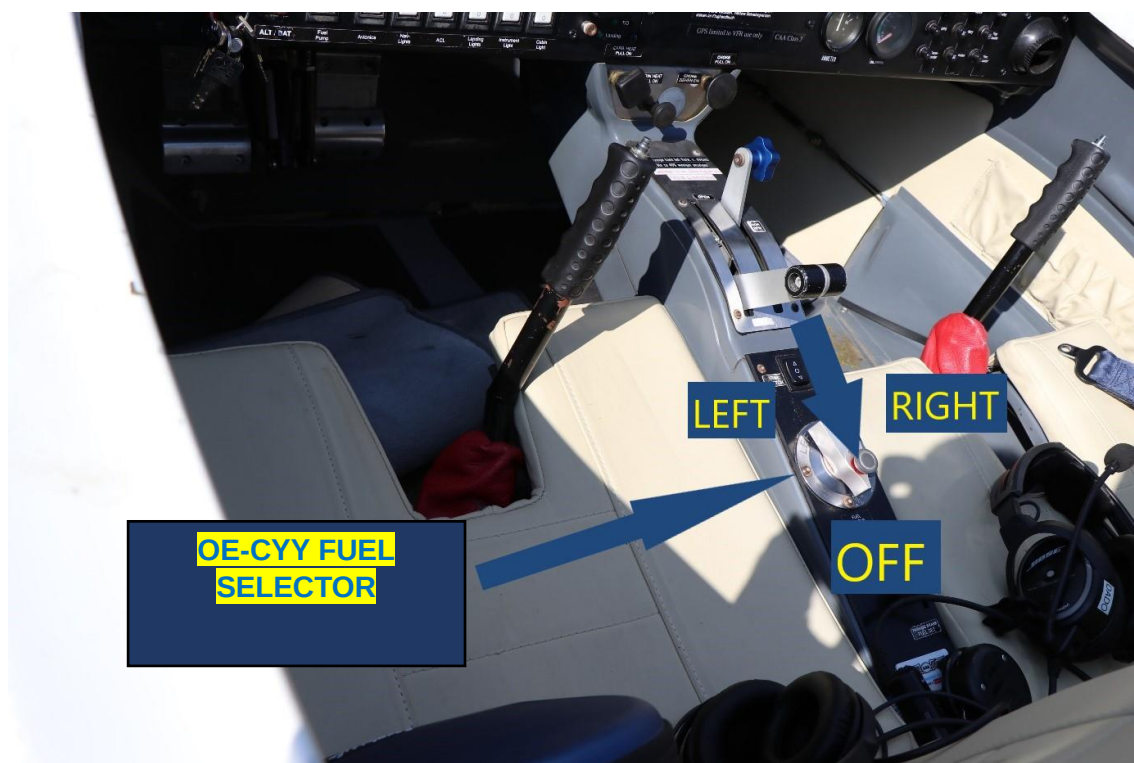
Figure 6: The position of the fuel selector OE-CYY at the scene immediately after the accident

The aircraft's fuel system consists of two fuel tanks, one in each wing. The capacity of each tank is 60 litres, and the unused part of the fuel in the system is 5.2 litres. The tanks are limited at the top and bottom by the wing fairing, which is specially reinforced at these points. The supply of fuel from the tanks to the carburettors is made possible by a motorised fuel pump. In addition to the engine fuel pump, an electric fuel pump is also connected to the system, which serves as a reserve pump in the event of an engine pump failure or if the fuel pressure is too low. Low fuel pressure in the fuel supply lines in the carburettor is detected by low fuel pressure sensors and indicated by a red warning light on the instrument panel in the aircraft cabin. The electric fuel pump must be switched on when a "low fuel pressure" warning is displayed. As part of the fuel system, a fuel selector switch with 3 positions is installed to select the tank in use and to cut off the fuel supply. It is located on the central part — the pedestal between the seats in the cockpit - Figure no. 6. During the investigation at the scene, the fuel selector switch was in the OFF position - the fuel supply was switched off.

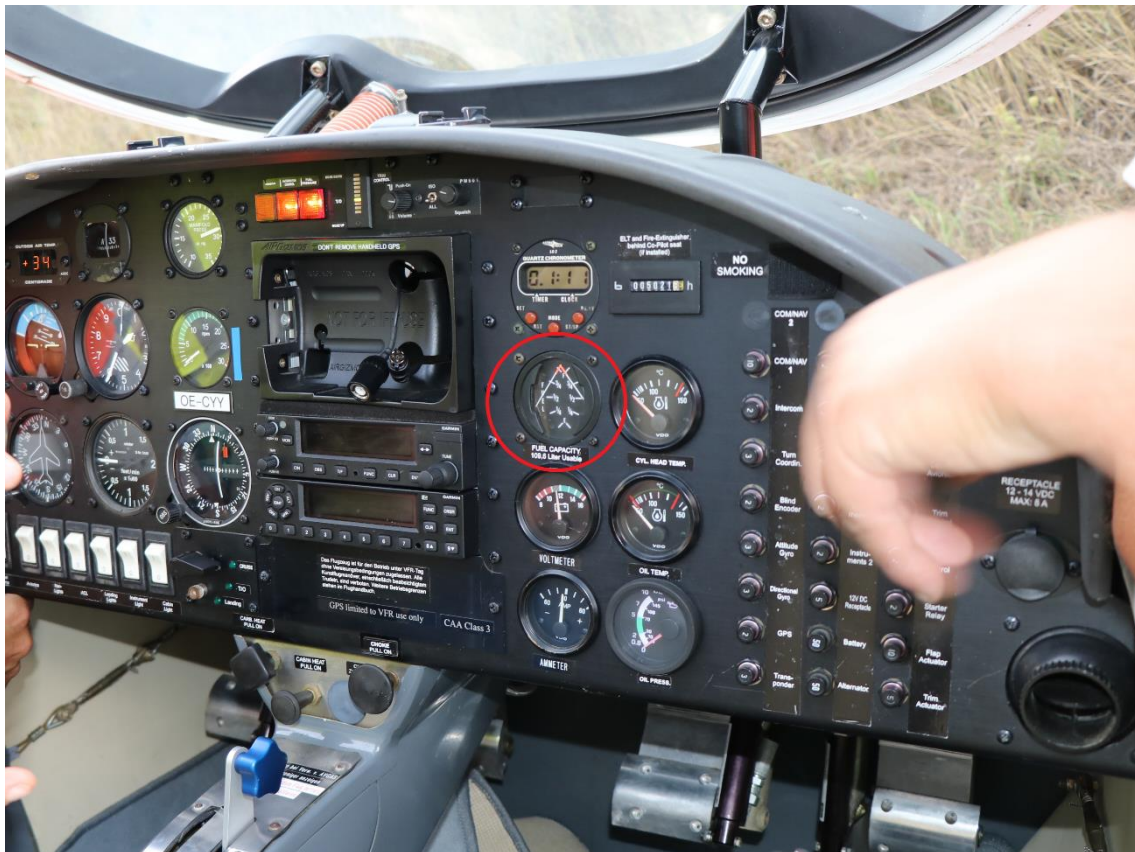
Figure 11: Position of fuel instrument indicators at the scene

Immediately after the accident, the investigating authority was informed by ReCO and OKC Kranj. The scene of the accident was secured by the police until the arrival of the chief investigator. The pilot of the aircraft, a passenger, representatives of the police, fire brigade, and DARS were present at the scene of the accident to ensure the safety of traffic on the AC. The on-site investigation included a visual inspection of the amount of fuel in the wing tanks. It was found that the left wing tank was empty, while the right wing tank still contained about 1/2 fuel. The fuel quantity indicator in the aircraft cabin showed the maximum deviation of both indicators in the full position (Figure no. 11 (FULL)).

- If there is a loose contact or if the contact of the grounding wire on the back of the device is exposed, both pointers of the measuring device indicate full or are in an extreme position.

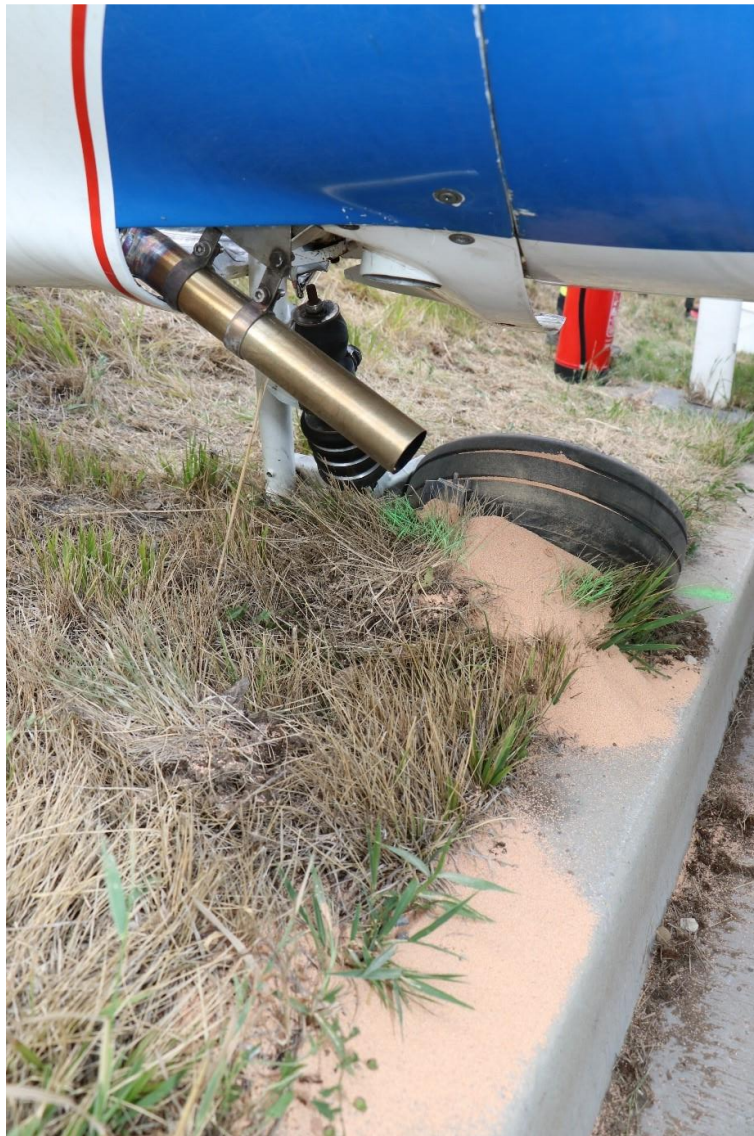
*Figure 12: A small amount of fuel leaked from a fuel drain valve at the scene*

There was a fuel stain about 20 cm in diameter at the edge of the highway lane. According to the statements and documents obtained by the first responders at the scene of the accident, the fuel dripped for several minutes from the drain valve, which was pushed through the torn-off panelling of the lower part of the nose of the aircraft. The approximate amount of fuel that leaked from the depressed drain valve is between 2 and 3 litres (the leaked fuel was absorbed by the firefighters, Figure 12).

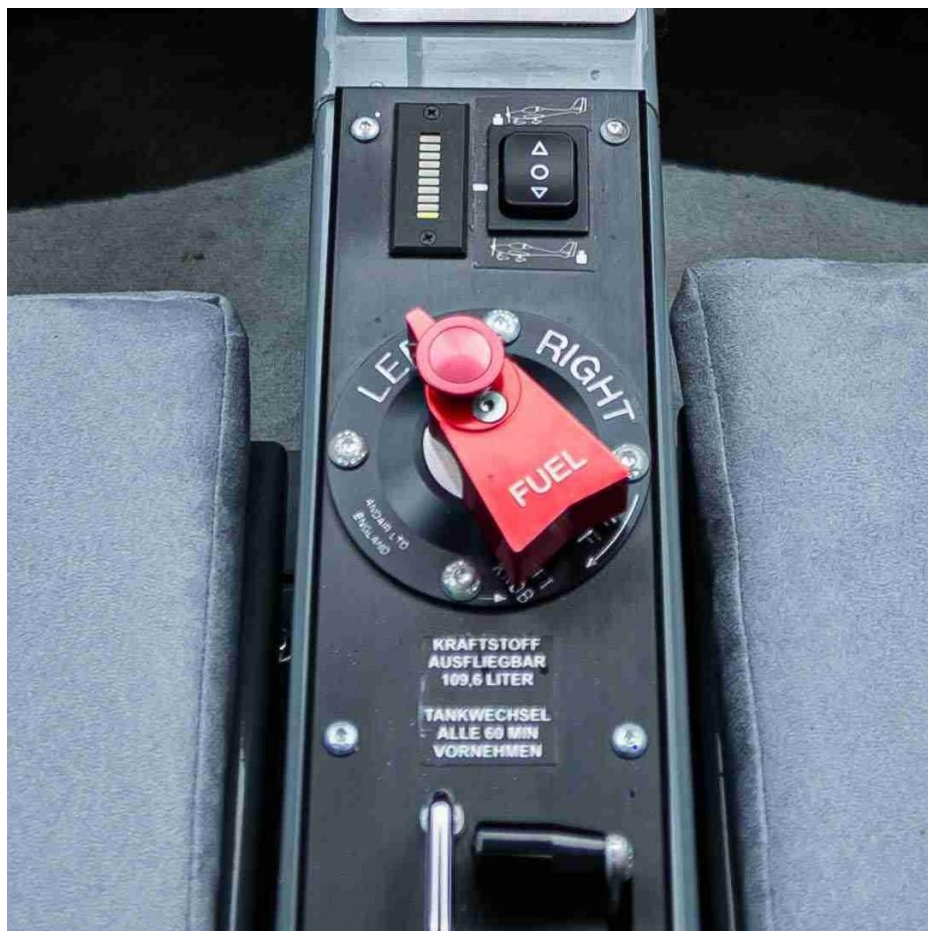
Figure 13: The position of the fuel selector at the time of the event

After completing the pre-flight inspection, the pilot set the fuel selector switch to the "LEFT" position and assumed that there were 50 litres of fuel in each of the two tanks, i.e., a total of 100 litres.

- The engine stopped due to a lack of fuel in the left wing tank, which caused the fuel at the position of the fuel selector switch to reach the engine to consume fuel from the left tank, for which the fuel instrument on the instrument panel in the aircraft cabin displayed the incorrect fuel quantity value.

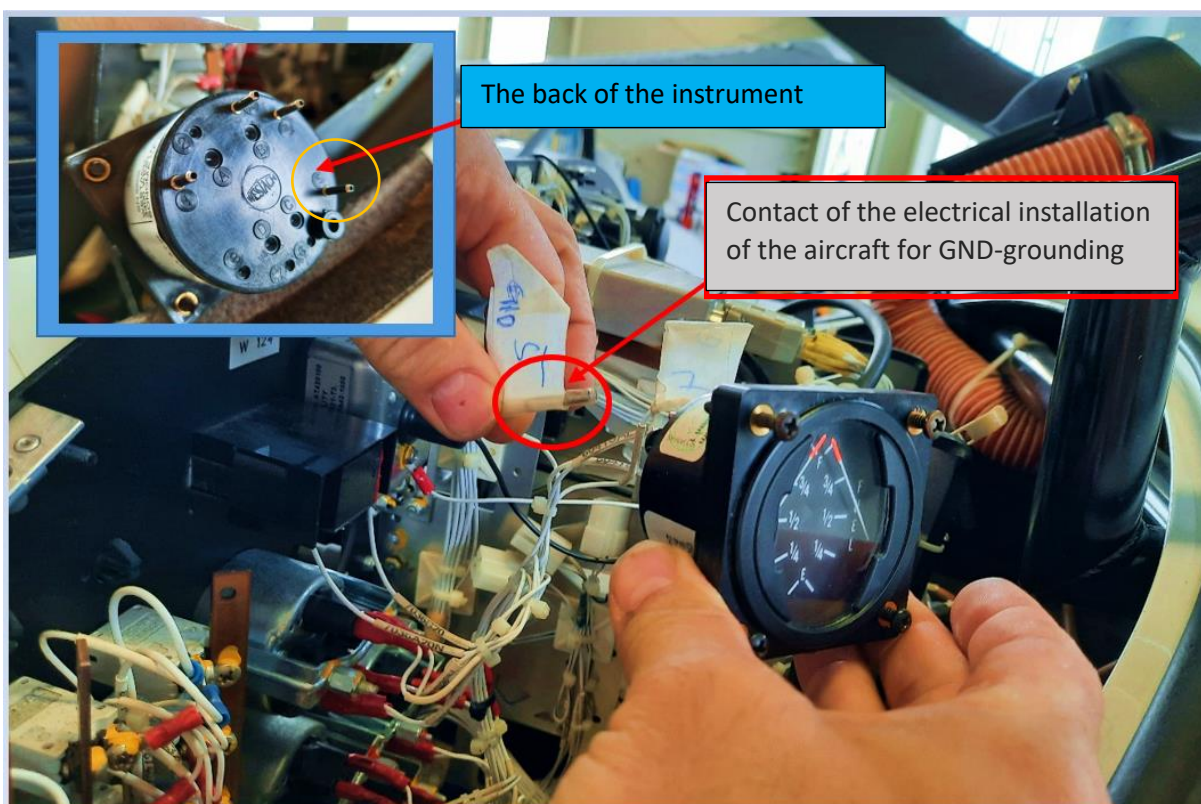
Figure 15: Display of a separate grounding contact: the instrument pointers indicate a position above the FULL (F) mark

When draining the fuel from both tanks, the amount of fuel in the left tank was measured at 0.16 litres. The amount of fuel measured in the right tank was 31 litres. No water was found in the fuel. The water drainage system and the entire fuel installation system were checked to detect possible leaks. When checking the function of the fuel gauge on the cockpit instrument panel, it was found that one of the connection contacts on the back of the instrument was loose. The female part of the contact was approximately 2/3 outside the length of the male contact and in the non-contact position.

The display of the manufacturer's device <sup>5</sup>was compared with the position of the GND wire (GND is the abbreviation for "ground"). It turned out that the fuel quantity display is correct if the contact of the ground wire is correctly fitted (Figure 14). If the ground wire contact is loose or protruding (Figure 15), both fuel quantity instrument displays are completely off in the top position. **Such an instrument display can be identified as full of fuel.**

- The interruption of the GND contact in the electrical installation of the aircraft is due to the loose contact of the non-matching contacts of the instrument with the electrical installation. The interruption of contact was most likely due to the influence of high temperatures, vibrations, or changes in the structure of the material.

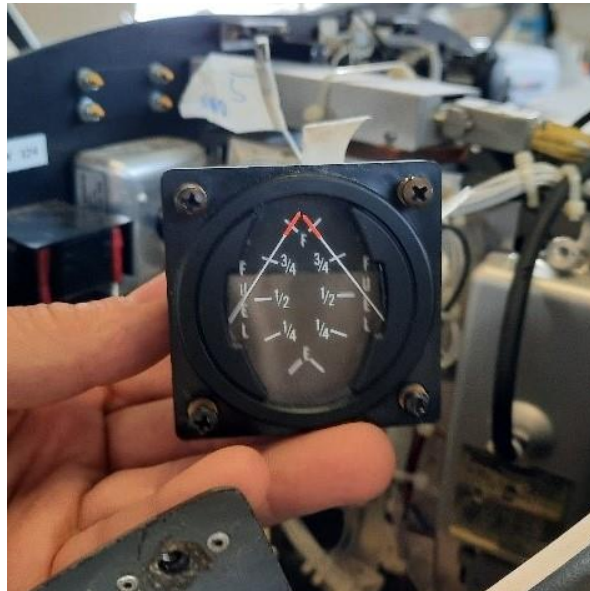
Figure 17: Indicators of the instrument when the GND contact is not connected

It was found that the pointers of the fuelling instrument of the same manufacturer in another aircraft<sup>6</sup> have an identical position when the GND contact is disconnected, namely that both pointers are in the outermost upper position (Fig. No. 17).

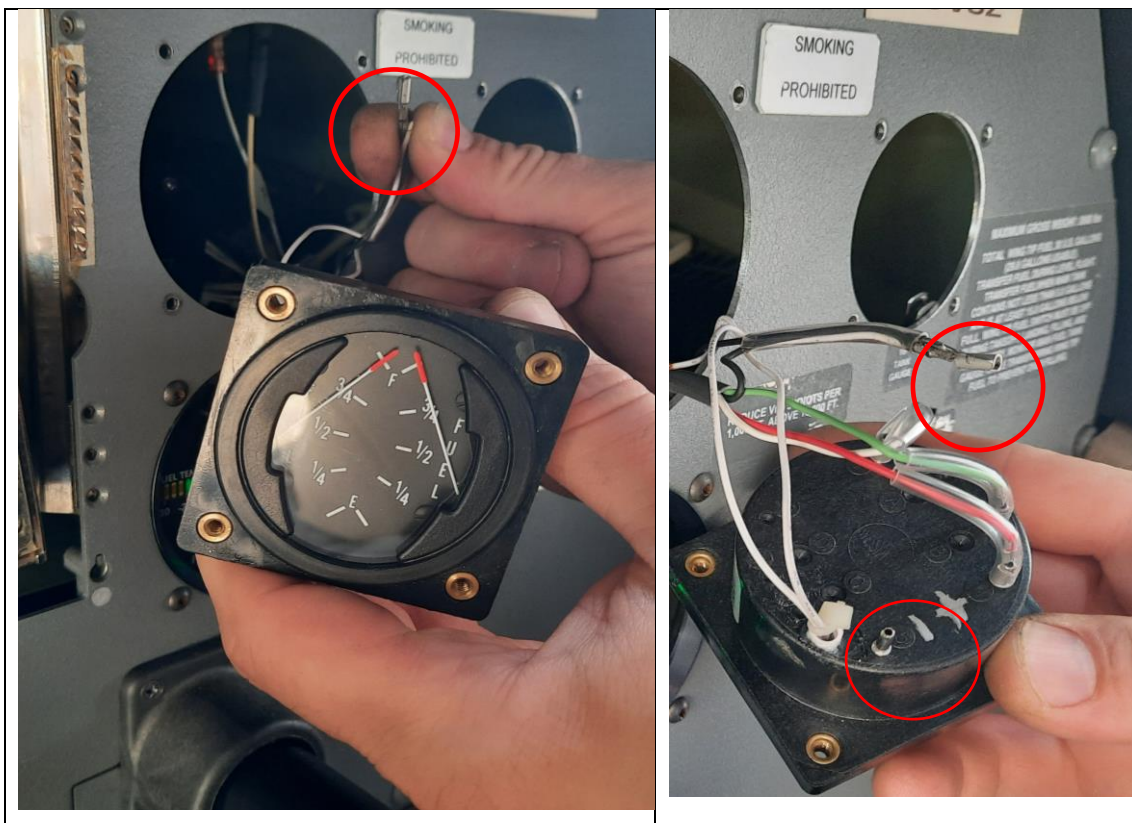
Figure 20: Performance check of the Westach fuel instrument on another GA category aircraft

As part of the investigation, an analysis was carried out on another Cessna 206 GA aircraft equipped with an identical instrument from the same manufacturer, Westach, as the instrument in the aircraft involved in the accident. It was found that the pointers of the fuel instrument of another aircraft indicate the maximum deviation "full" in the event of an interruption of the GND contact, which is identical to the case of an interruption of the GND contact of the OE-CYY aircraft (Figure No. 15).
