## ALERT SERVICE BULLETIN

# Fuel pump assembly for ROTAX® Aircraft Engine Type 912 i (Series)

ATA System: 73-10-00 Fuel system

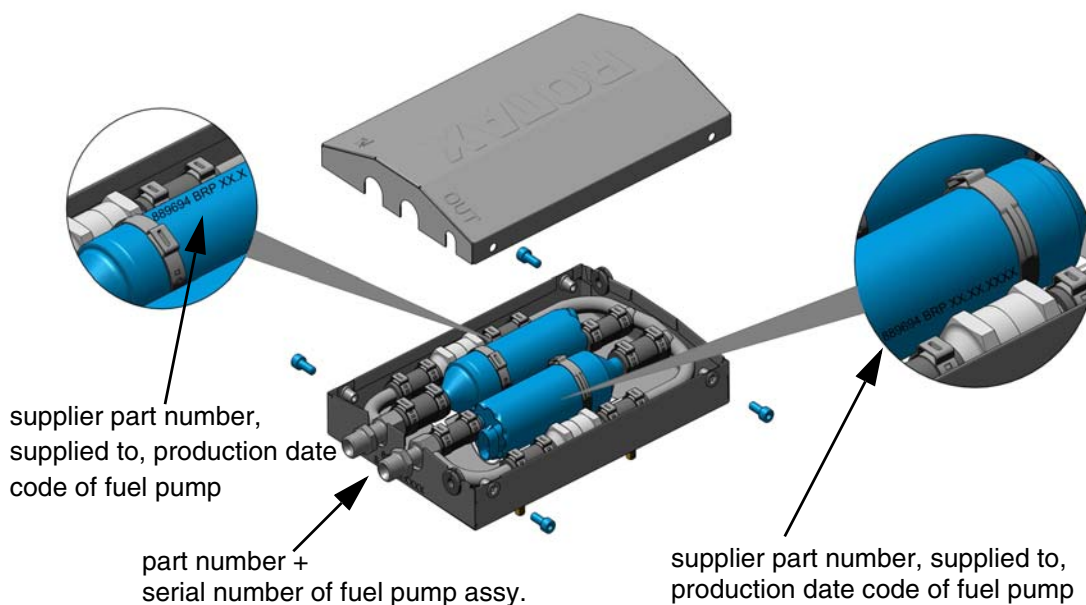
See Fig. 1 for information on how to find the part no. and S/N on the fuel pump assy.
