| <br>DOA Nr.: EASA.21J.025 | Technische Mitteilung / Service Bulletin | Dokument Nr.:<br><b>SB-AT01-045</b> |

## Kontrolle Kraftstoff-Rücklaufleitungen / Check of Fuel Return Lines

AT01 / AT01-100 / AT01-200:

**100 bis 403 und 405**  
(404 und ab 406 serienmäßig)

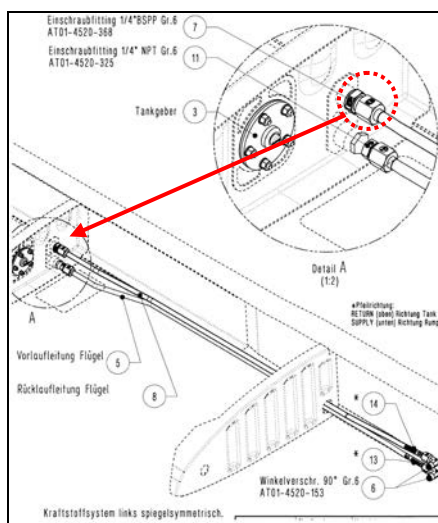
possibly affected fitting

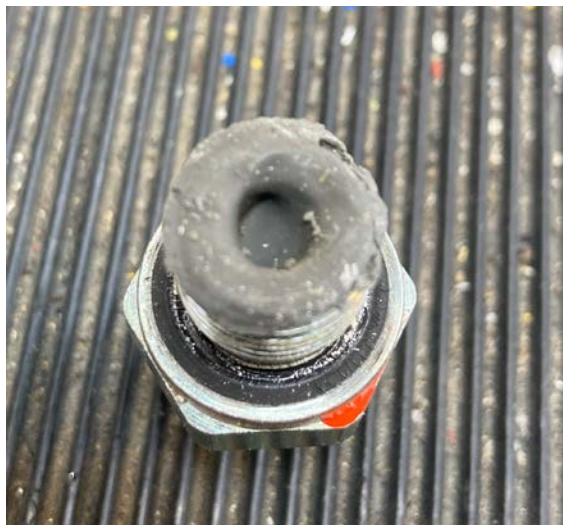
A fitting in the fuel return line was found blocked by tank sealant, presumably since manufacture. This could cause anomalies in the engine's fuel supply.

found affected fitting

1. Appropriate check for blockage (e.g. pump air into the fuel return line using a hand pump and check for unobstructed flow to both tanks on the open tank filler neck by listening for air bubbles)
2. Exchange of the respective tank return fitting if the result is positive
3. Inform AQUILA about any positive finding.
