## Service Information SI-AT01-018

Type: AQUILA AT01,  
 Models: AT01; AT01-100; AT01-200  
 affected S/N:

Continuous modifications and changes to parts and appliances are cumulatively detailed and published within this SI.

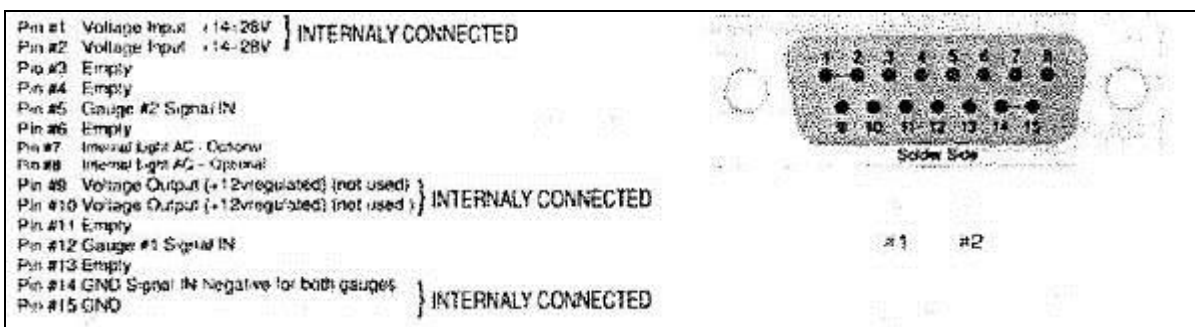
PIN- old

changed pins

**Note:** After installation of a new fuel gauge calibration to zero at unusable fuel in both tanks has to be checked (reading slightly below “E”, not above).

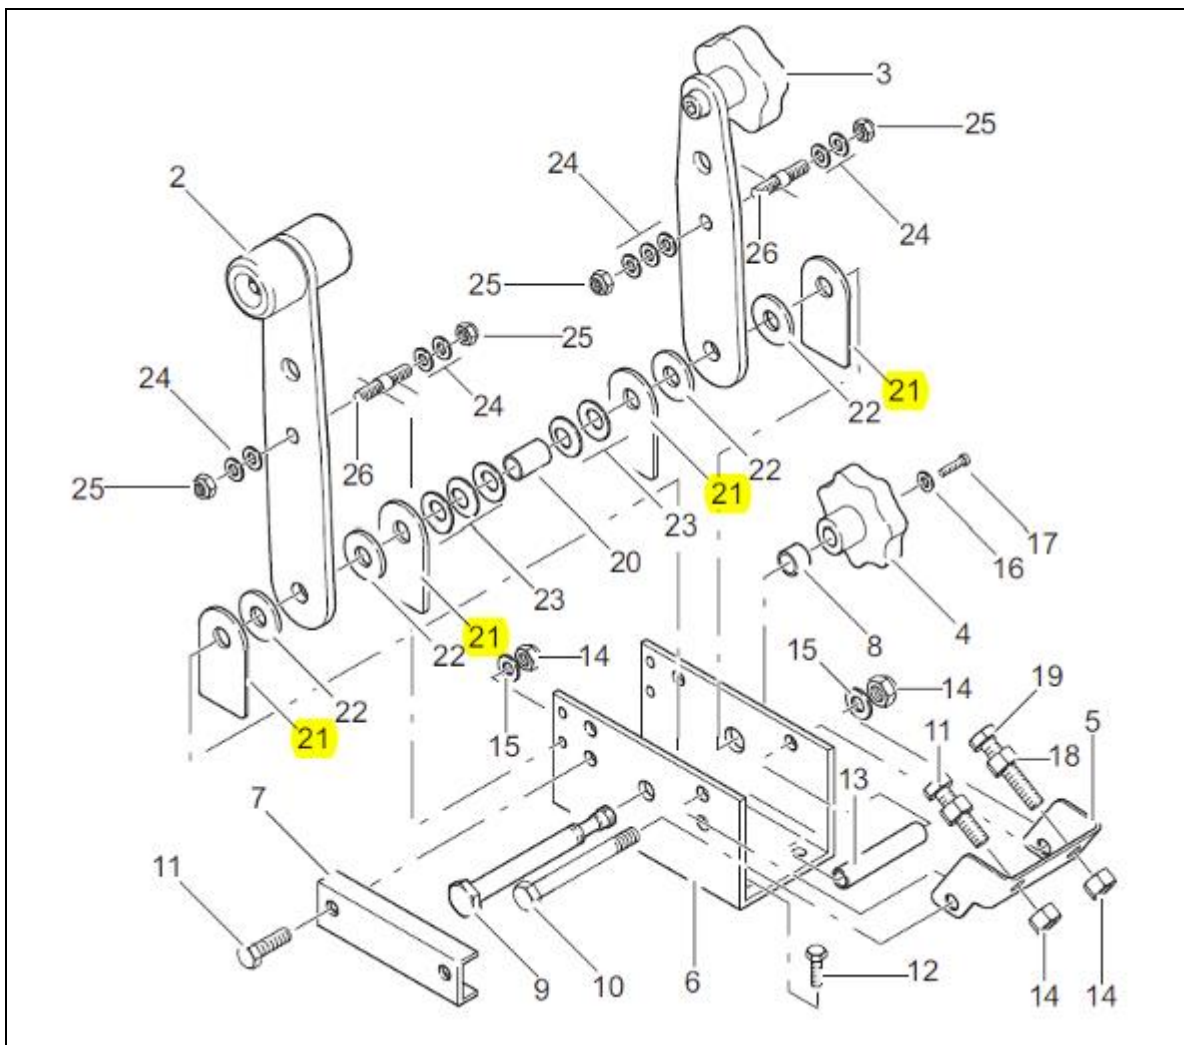
Skizze 1: verbesserter Triebwerksbedienungs-Quadrant (7020-001-010-R01)

Bei notwendigem Austausch des Triebwerkbedienungs-Quadranten (7020-001-010) wird eine verbesserte Version (7020-001-010-R01) empfohlen.

Also a retrofit (see figure 1, position 21) is possible, if the 4 washers (DIN9021 8,4x24mm) are replaced by the four metal sheets (7020-145-R00).

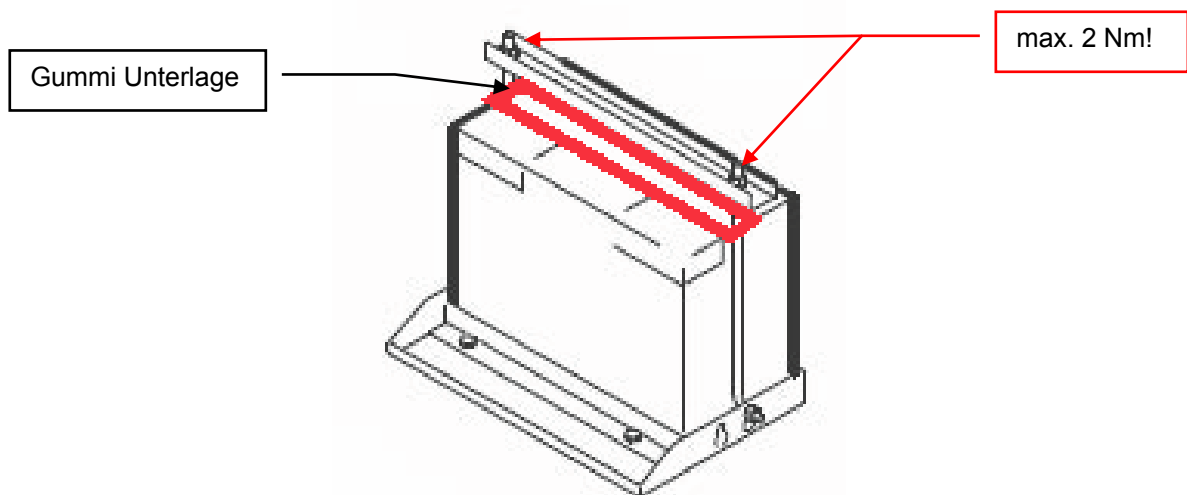
Um mechanische Beschädigungen an der Batterie zu vermeiden, wird eine Gummi Unterlage 1,5x175x15mm (mit doppelseitigem Klebeband oder geeignetem Kleber an Aluminium-U-Profil befestigt) zwischen Batteriehaltebügel (Al-U-Profil) und Batterie empfohlen.

To avoid mechanical damage to the battery a rubber underlay 1,5x175x15mm (glued with double-faced adhesive tape to the aluminum U-profile) between the battery hold down bracket (Al-U-profile) and the battery is recommended.

Also the recommended torque for the self-locking nuts at the hold down bracket is **max. 2Nm**.

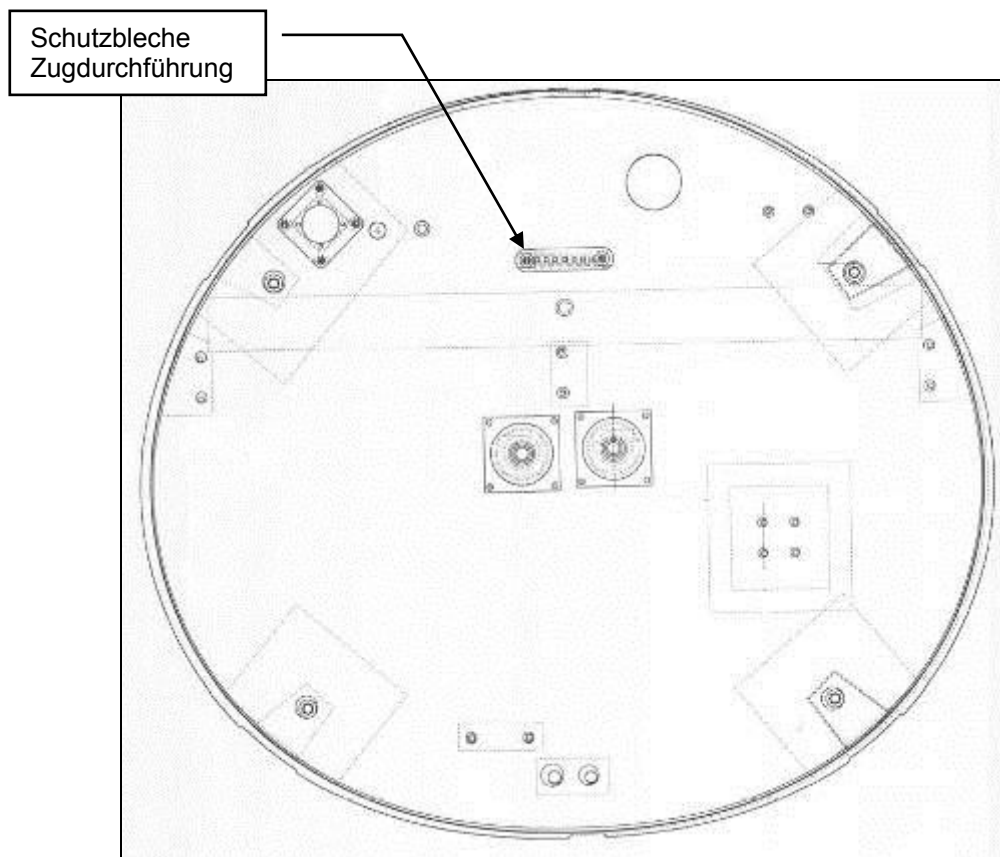
Brandschott AQUILA AT01 Modell AT01 und AT01-100

In case of increased friction or friction induced noise within the engine controls (throttle, propeller- or choke lever) it is a possible cause that the cover plates at the firewall cut-out have cut into the casing of the engine control bowden cables.

Therefore an exchange with thicker plates (1,0mm) is recommended.

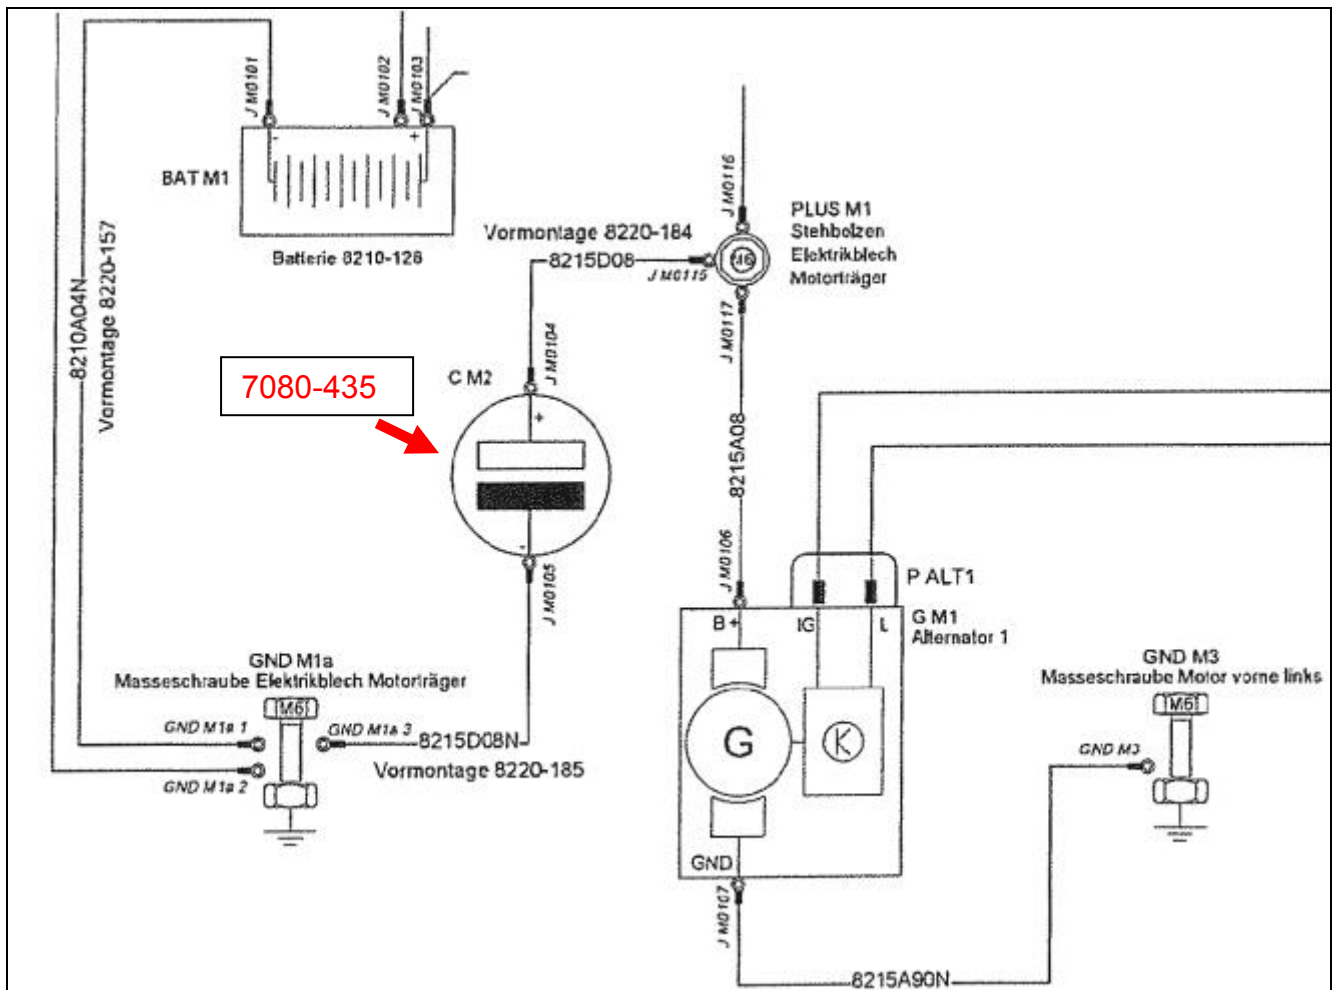
To minimize interference induced by voltage fluctuations, retrofit of a capacitor for the external generator is recommended.

- electrical connection according wiring diagram:

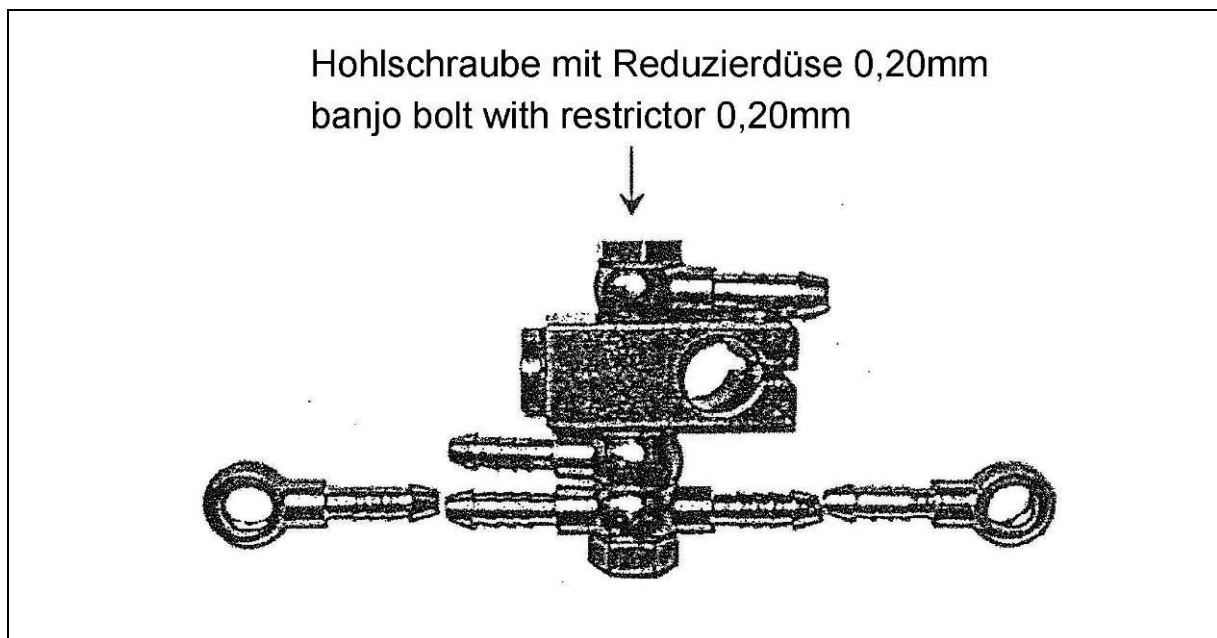
To eliminate these short term fuel pressure drops, the fuel return line restrictor may be replaced.

Check fuel pressure during ground run at power change from idle to full throttle with and without electrical auxiliary fuel pump.

Implementation of SI-AT01-018 annex 11 has to be approved and released to service by certifying staff.

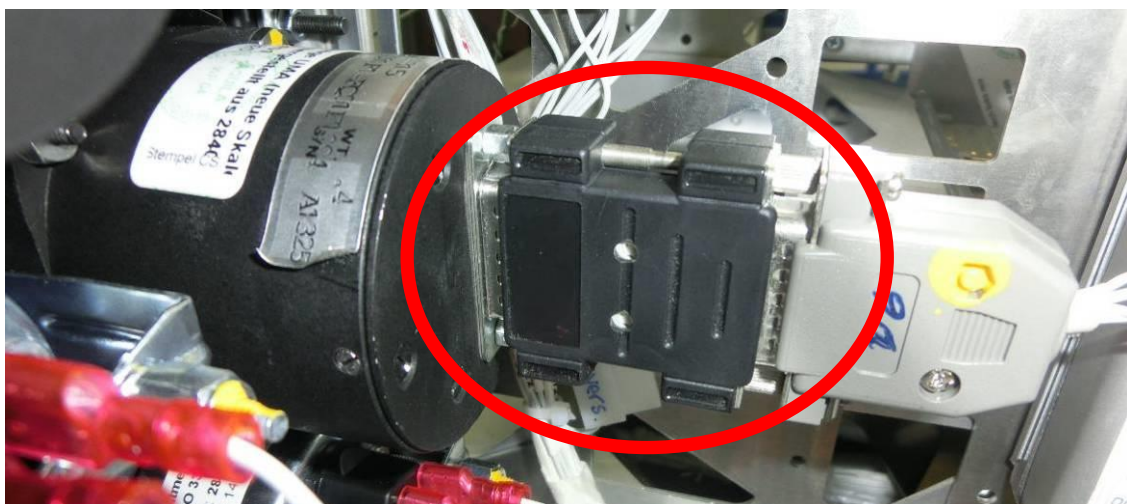
Installation of calibration module

For easier calibration of UMA fuel gauges with floats a calibration module is recommended (module is standard from S/N AT01-100A/B-327). The retrofit of this module is described below.

4. Remove glare shield.
5. Remove connector at the back of the fuel gauge.
6. Check type of fuel gauge (new/old pin-out, AT01-2840-206 or AT01-2840-220, refer to annex 1 of this SI for further information)
7. Install correct calibration module (AT01-8040-001 or AT01-8040-002) between fuel gauge and harness connector as shown below:

8. Perform fuel quantity indication system calibration according to maintenance manual.
9. Reinstall glare shield.

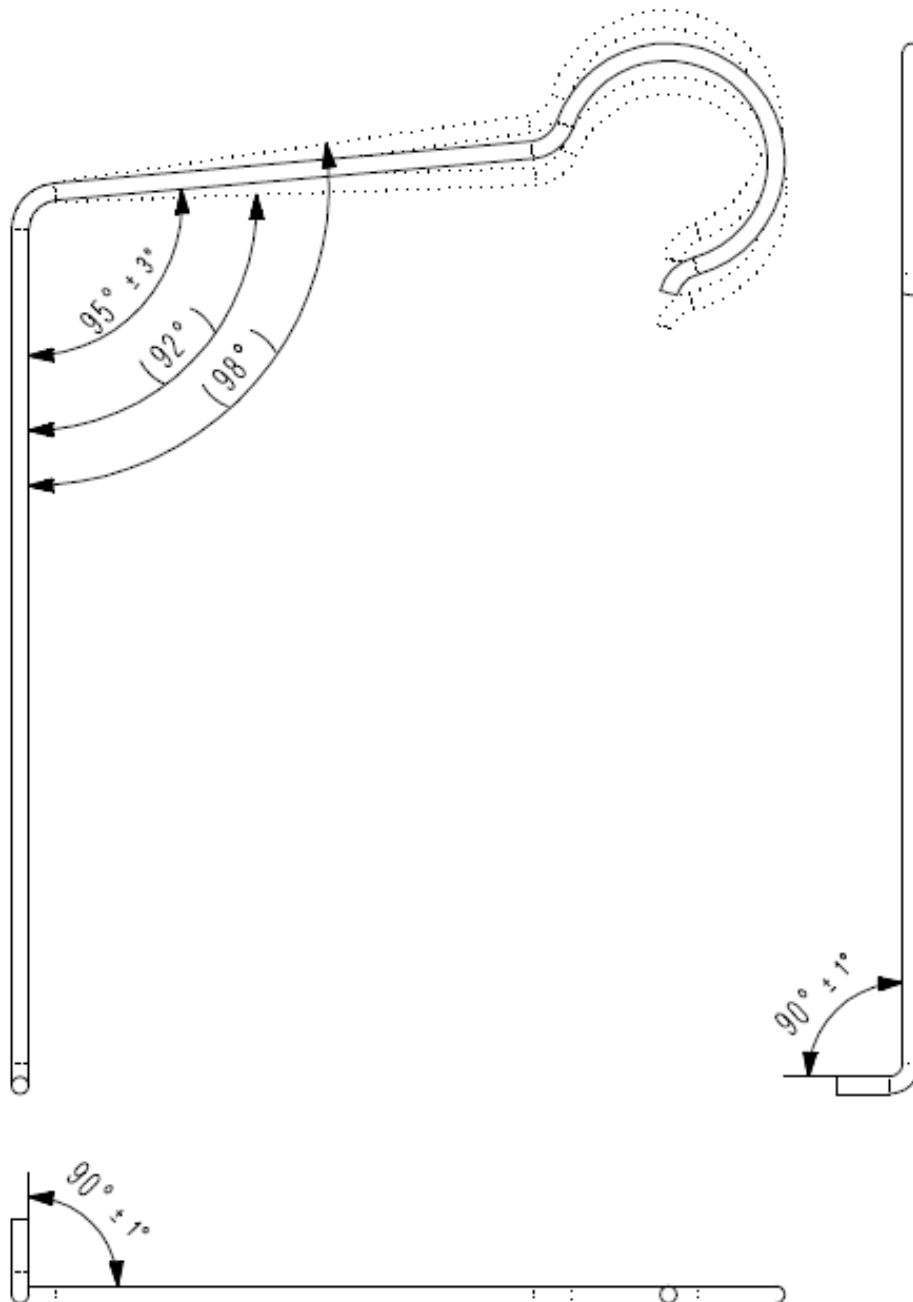
Float lever (AT01-8030-186) for fuel level sensors up to S/N AT01-326

**Caution:** Check that float lever movement is not blocked by the fuel slosh rib for bend angles >95°!

After bending the lever a recalibration of the fuel quantity indicating system is necessary!

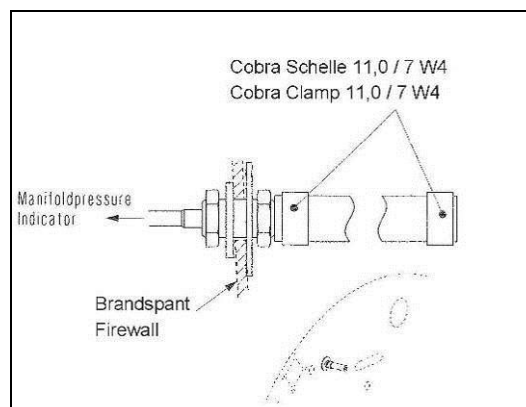
Teilweise wurde die Ladedruck-Verbindungsleitung vom Brandspant zur Vergaserbrücke mit Kabelbindern gesichert. Um eine genaue Messung zu gewährleisten, sollten Cobra Schellen verwendet werden.

**neu:** 2x Cobra Schelle 11,0 / 7 W4 (AQUILA TNr. **4520\_COBRA\_11,0/7W4**)

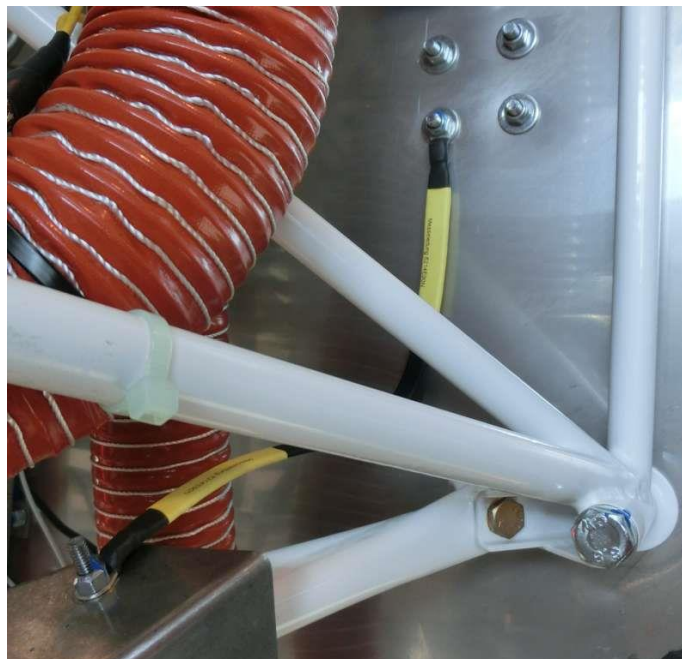
### Photo:

At every 100h maintenance check a bonding measurement between the fuel tank filler and the exhaust pipe (grounding point during refueling) is required. Service history has shown that the electrical bonding in the spring-loaded flange connection between the exhaust pipe and the muffler deteriorates due to build-up of exhaust deposits. This can lead to an exceedance of the 1 Ohm limit.

- Remove one lock nut each from the rear shock mount of the exhaust pipe and from the mounting bracket of the canopy mechanism support at the firewall
- Mount the bonding strap 8214E90N according to the photo below
- Install two new lock nuts
- Perform bonding measurement according to AMM

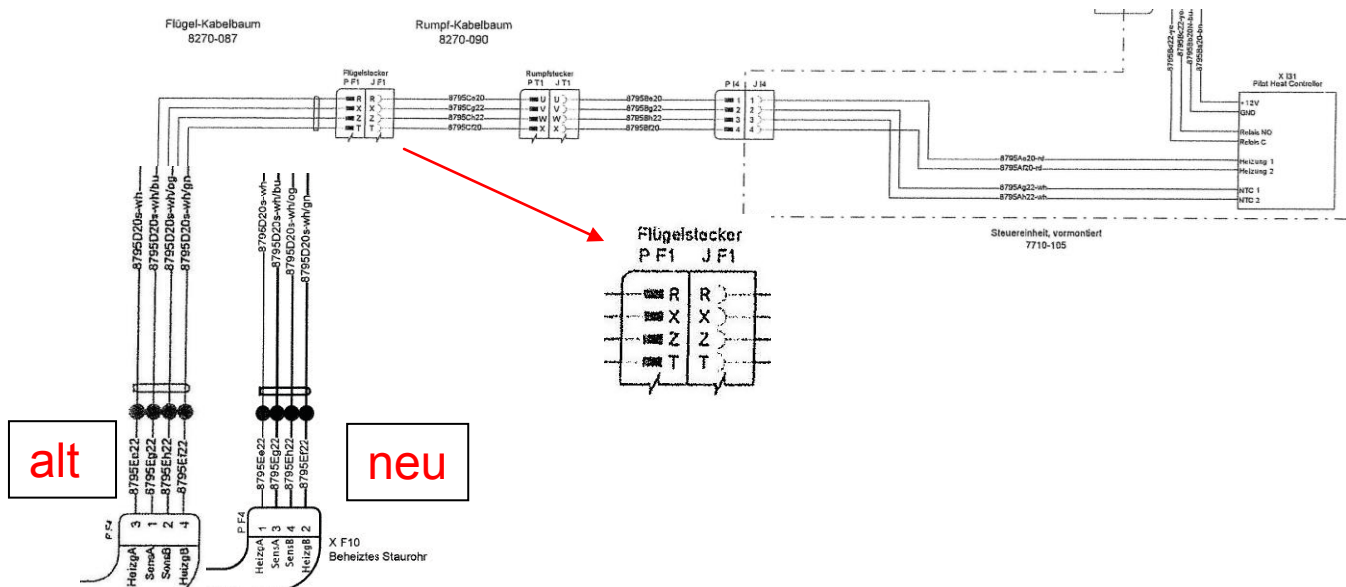
Die bisherige Ausführung des beheizten Pitot-Rohres mit Abdichtung über eine Quetschbuchse hatte eine hohe Ausschussrate wegen Undichtigkeit. Es wurde eine neue Version mit Lemo-Buchse und Lemo Stecker freigegeben. Nun ist die Pin-Belegung an Lemo-Buchse / Stecker angepasst worden. Die bisherigen Bauformen (AQUILA TNr. 7710-104-R04 und davor) werden nicht mehr hergestellt.

The design of the heated pitot tube with pressure sealing via a screwed cable gland had a high scrap rate due to leakiness. A new version with Lemo socket and Lemo plug was approved. Now the pin assignment at the Lemo socket / plug has been changed.

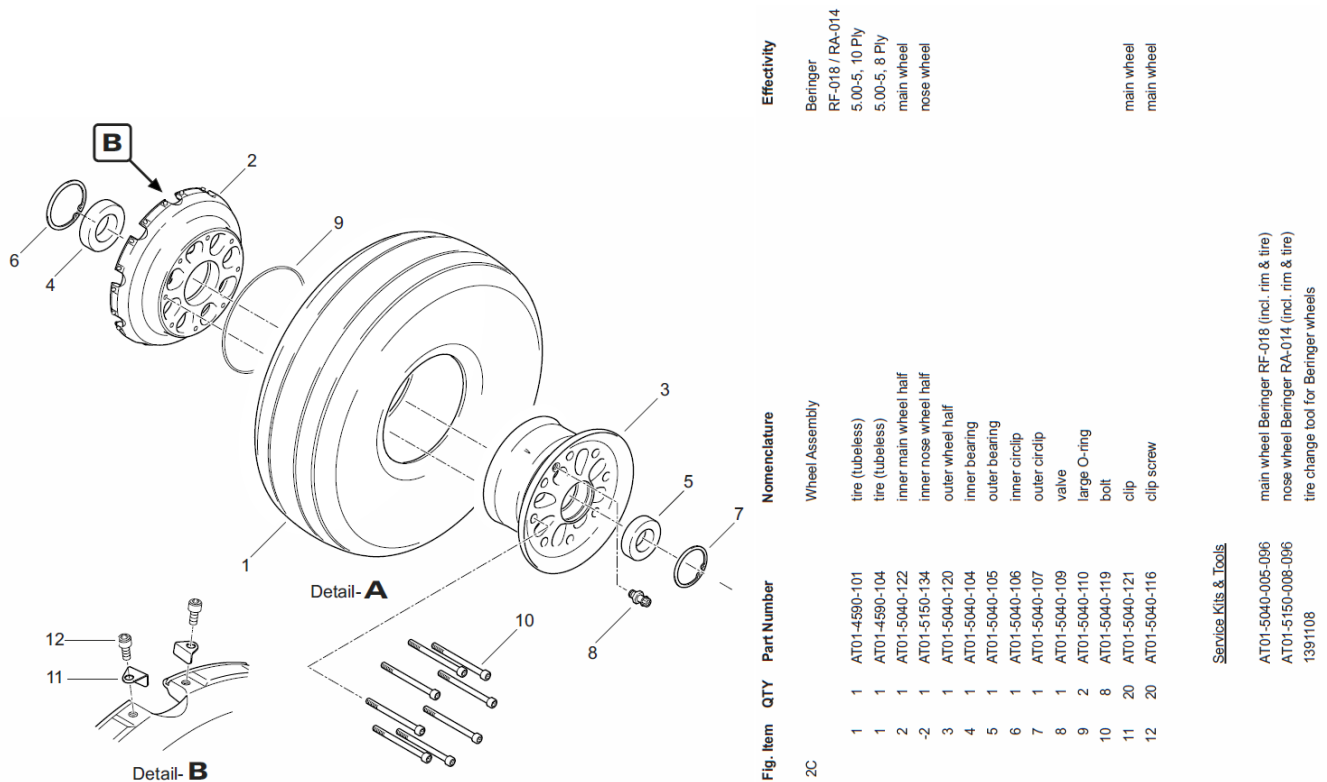
Abb.: Auszug aus zukünftigem IPC

Ersatzteile für die bisherigen 3-teiligen Felgen werden nicht mehr produziert und es kann bei Teilbeschädigungen ein Austausch der gesamten Felge nötig werden. Die Fa. Beringer bietet hierzu ggf. spezielle Konditionen an, die direkt mit Fa. Beringer zu verhandeln sind.

**Reifen 5.00-5/8/160, 8 ply**  
**TUBELESS Michelin Aviator, P/N: 021-310-0:** AQUILA TNr. **4590-104**

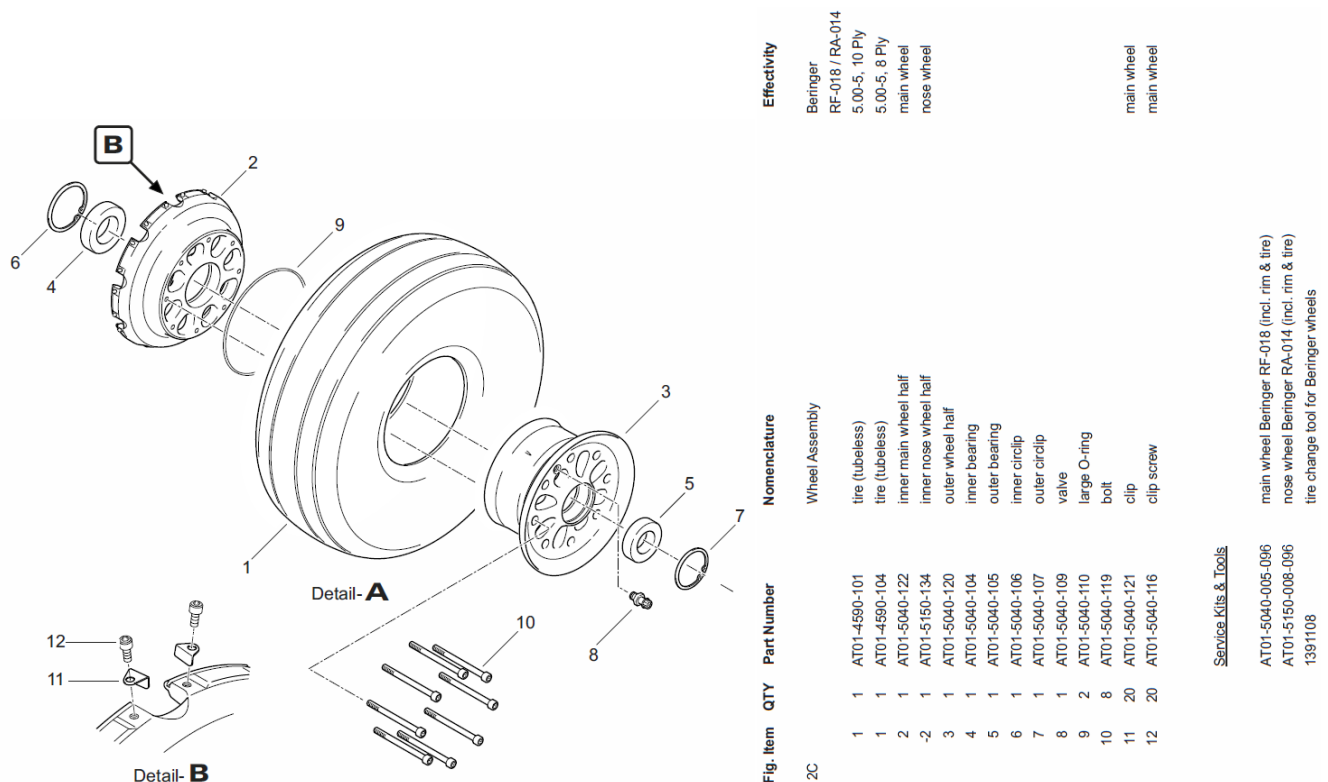
fig.: extract from draft IPC

Because of poor availability also the **tires** approved for the AQUILA Beringer landing gear (**Michelin 10Ply** P/N 071-311-0) are replaced by **alternative tires (Michelin 8Ply** P/N 021-310-0).

Spare parts for the 3-parts wheels are also no longer in production which may lead to complete wheel exchange even in case of minor damage to a part. In such cases Beringer offers if applicable special conditions which have to be negotiated directly with Beringer.

**Replacements are 2-parts wheels** RF-018 for the MLG and RA-014 for the NLG.

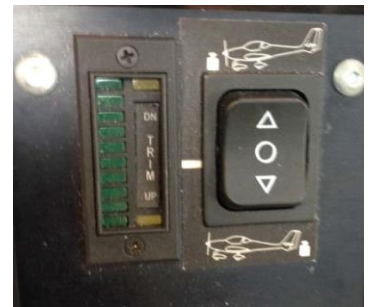
Example AT01-100

The Ray Allen LED Trim Position Indicator RP3 is no longer in production. The retrofit to the electrically identical but slightly bigger successor model RP4 is approved herewith in case of the need for replacement.

1. Disconnect electrical connector and remove defective trim position indicator
2. Enlarge Panel Cut Out acc.sketch below (ca. +1,5mm in height and width)  
**Suction the resulting chipping appropriately!**
3. Install new trim position indicator (LEDs to LH) and restore electrical connection
4. Place indicator marking (DN Trim oriented up / forward)
5. Perform functional test
- (6.) If indicator is unsteady, or interfered during COM use, exchange Pin 1 (green) and Pin 2 (blue), afterwards readjust trim range if needed

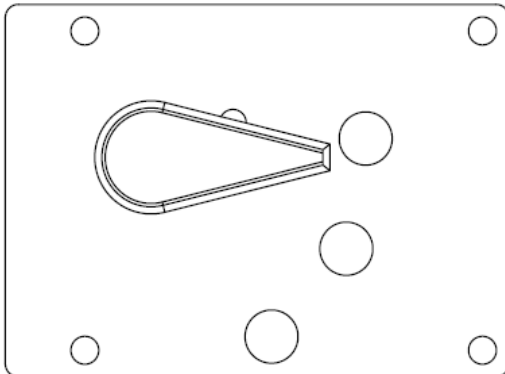
**AT01-8220-067**  
*Klappenschalter alt*

Der bisherige Landeklappenschalter AT01-8220-067 wird nicht mehr hergestellt und kann bei Bedarf durch den neuen Schalter ersetzt werden.

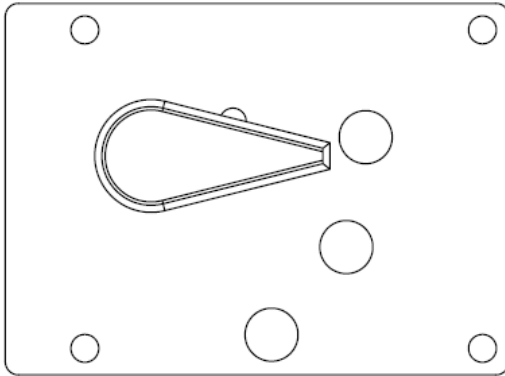
**AT01-8220-067**  
*Flaps switch old*

The flaps switch AT01-8220-067 is no longer in production.

The retrofit to the successor model is approved herewith in case of the need for replacement.

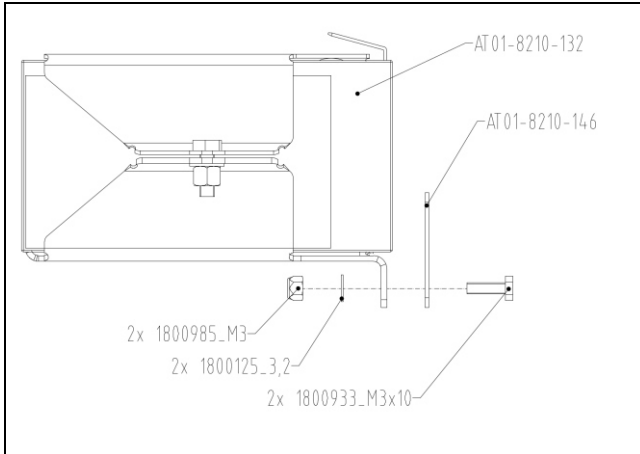
Einbau Zusatzbatterie **ALT**

Die bisherige Zusatzbatterie AT01-8210-132 wird nicht mehr hergestellt und kann bei Bedarf durch die neue Zusatzbatterie AT01-8210-133 ersetzt werden. Da die neue Batterie geringfügig andere Abmessungen hat, sind zu ihrer Befestigung andere / zusätzliche Befestigungselemente notwendig.

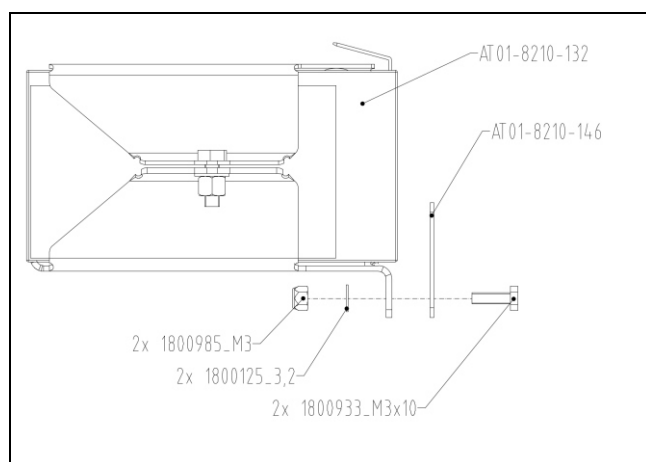
**FORMER** Integration of emergency excitation battery

The emergency excitation battery AT01-8210-132 is no longer in production. The retrofit to the successor model AT01-8210-133 is approved herewith in case of the need for replacement. Other/additional fastening elements are needed for attachment of the new battery, because it has slightly different dimensions.
