REPUBLIC OF SLOVENIA  
MINISTRY OF INFRASTRUCTURE

Number: 37200-5/2022/83  
Date: 13. 03. 2024

**FINAL REPORT**  
**ON THE ACCIDENT INVESTIGATION**  
of the AQUILA AT01 motor aircraft,  
reg. mark OE-CYY,  
near Lesce airport (LJBL),  
August 5, 2022

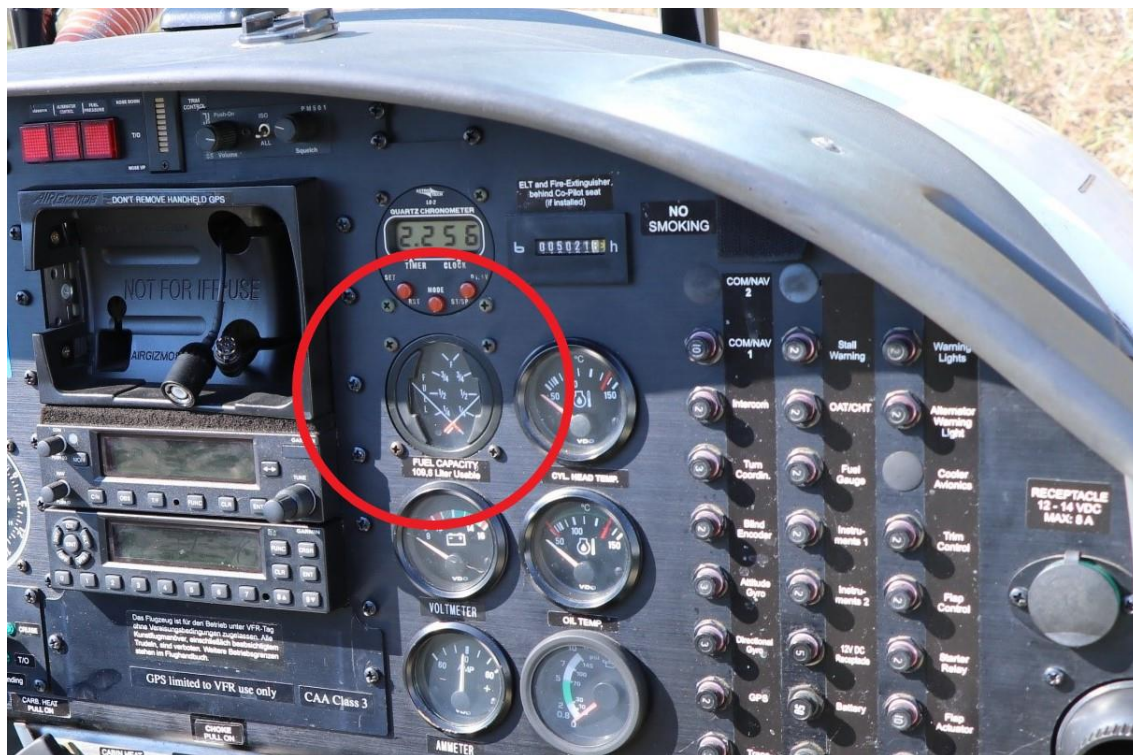
A fuel sensor is installed in each tank, which generates an electrical signal depending on the amount of fuel in the tanks and sends it to the fuel quantity displays on the instrument panel in the cockpit. The fuel quantity display shows the following values: FULL, 3/4, 1/2, 1/4, and EMPTY.

Figure 7: OE-CYY fuel gauge on the instrument panel in the aircraft cabin

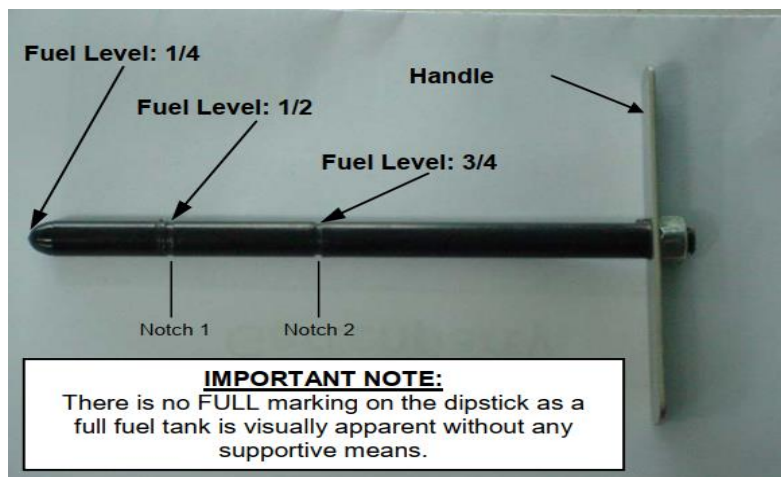
In addition to the above-mentioned method of measuring the amount of fuel in the tanks, there is also an additional, manual measurement method, which is a mandatory accessory on aircraft in this category and represents a priority control of the correct operation of the fuel quantity indicators. The procedure for checking the amount of fuel in preparation for flight is described in Chapter 4 (Normal Procedures) of the aircraft manual, AFM (point 4.4.2: Check before each flight, Figure no. 8). It is carried out with the help of a stick, which is dipped into the fuel tank through the opening of the fuel tank. After pulling the dipstick out of the fuel, check the position of the "wet" area on the dipstick according to the markings on the dipstick: 1/4, 1/2, and 3/4.

Figure 8: "Deep-Stic": a stick for manually measuring the amount of fuel in the tanks

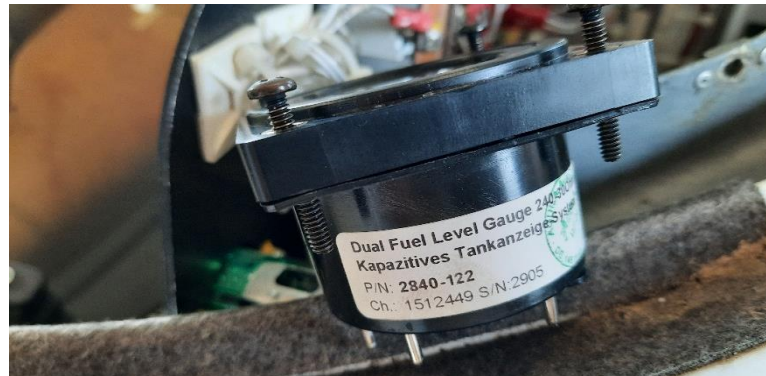
The manufacturer of the device has indicated on its website how the non-matching contacts of the device are to be connected to the electrical installation.

Figure 19: Westach Fuel Gauge, P/N: 2840-122
